Manhole Inspection Summary

Manhole # S43II_005MH

Insp Date: **10/23/07 11:26 AM**

Location Address: **1540 BROADWAY**

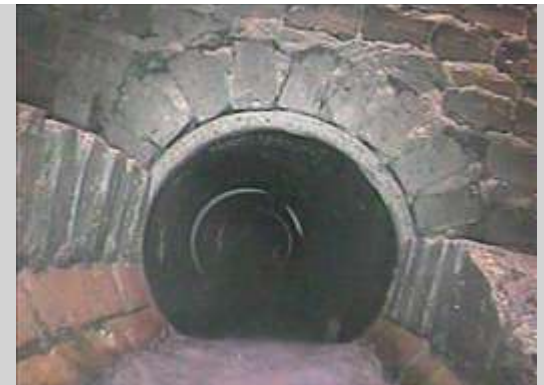
5 O'Clock Inflow

12 in. Circular Gravity Sewer
Pipe In @ 5 O'Clock

Pipe Height: **8.4** (in.) Rod and Bar
Pipe Material: **Clay** ☐ Pipe Lined
Invert Depth: **15.26** (ft.) Flow Characteristics: **Fast**
Deposits: ☒ None ☐ Mud ☐ Sludge ☐ Debris ☐ Grease
Silt Depth: (in.) Deposits Extent:
Infiltration: **None** Pipe Seal Cond: **Sound**

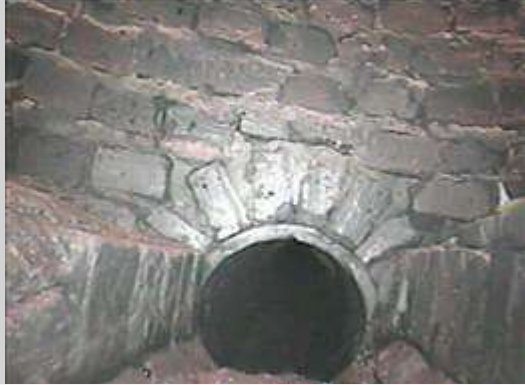
6 O'Clock Inflow

10 in. Circular Gravity Sewer
Pipe In @ 6 O'Clock

Pipe Height: **6** (in.) Rod and Bar

Pipe Material: **Clay** ☐ Pipe Lined

Infiltration: **None** Pipe Seal Cond: **Sound**
